NATIONAL DAM INSPECTION PROGRAM. COOKS POND DAM (NDI I.O. PA-00--ETC(U)
1981

PHASE I REPORT
NATIONAL DAM INSPECTION PROGRAM

NAME OF DAM: Cooks Pond Dam
STATE LOCATED: Pennsylvania
COUNTY LOCATED: Bradford
STREAM: North Branch of Beaver Creek
SIZE CLASSIFICATION: Small
HAZARD CLASSIFICATION: High
OWNER: Mr. E. W. Manchester
DATE OF INSPECTION: November 15, 1980 and February 4, 1981

COOKS POND DAM
NDI I.D. PA-0041
DER I.D. 008-035
NOVEMBER 15, 1980

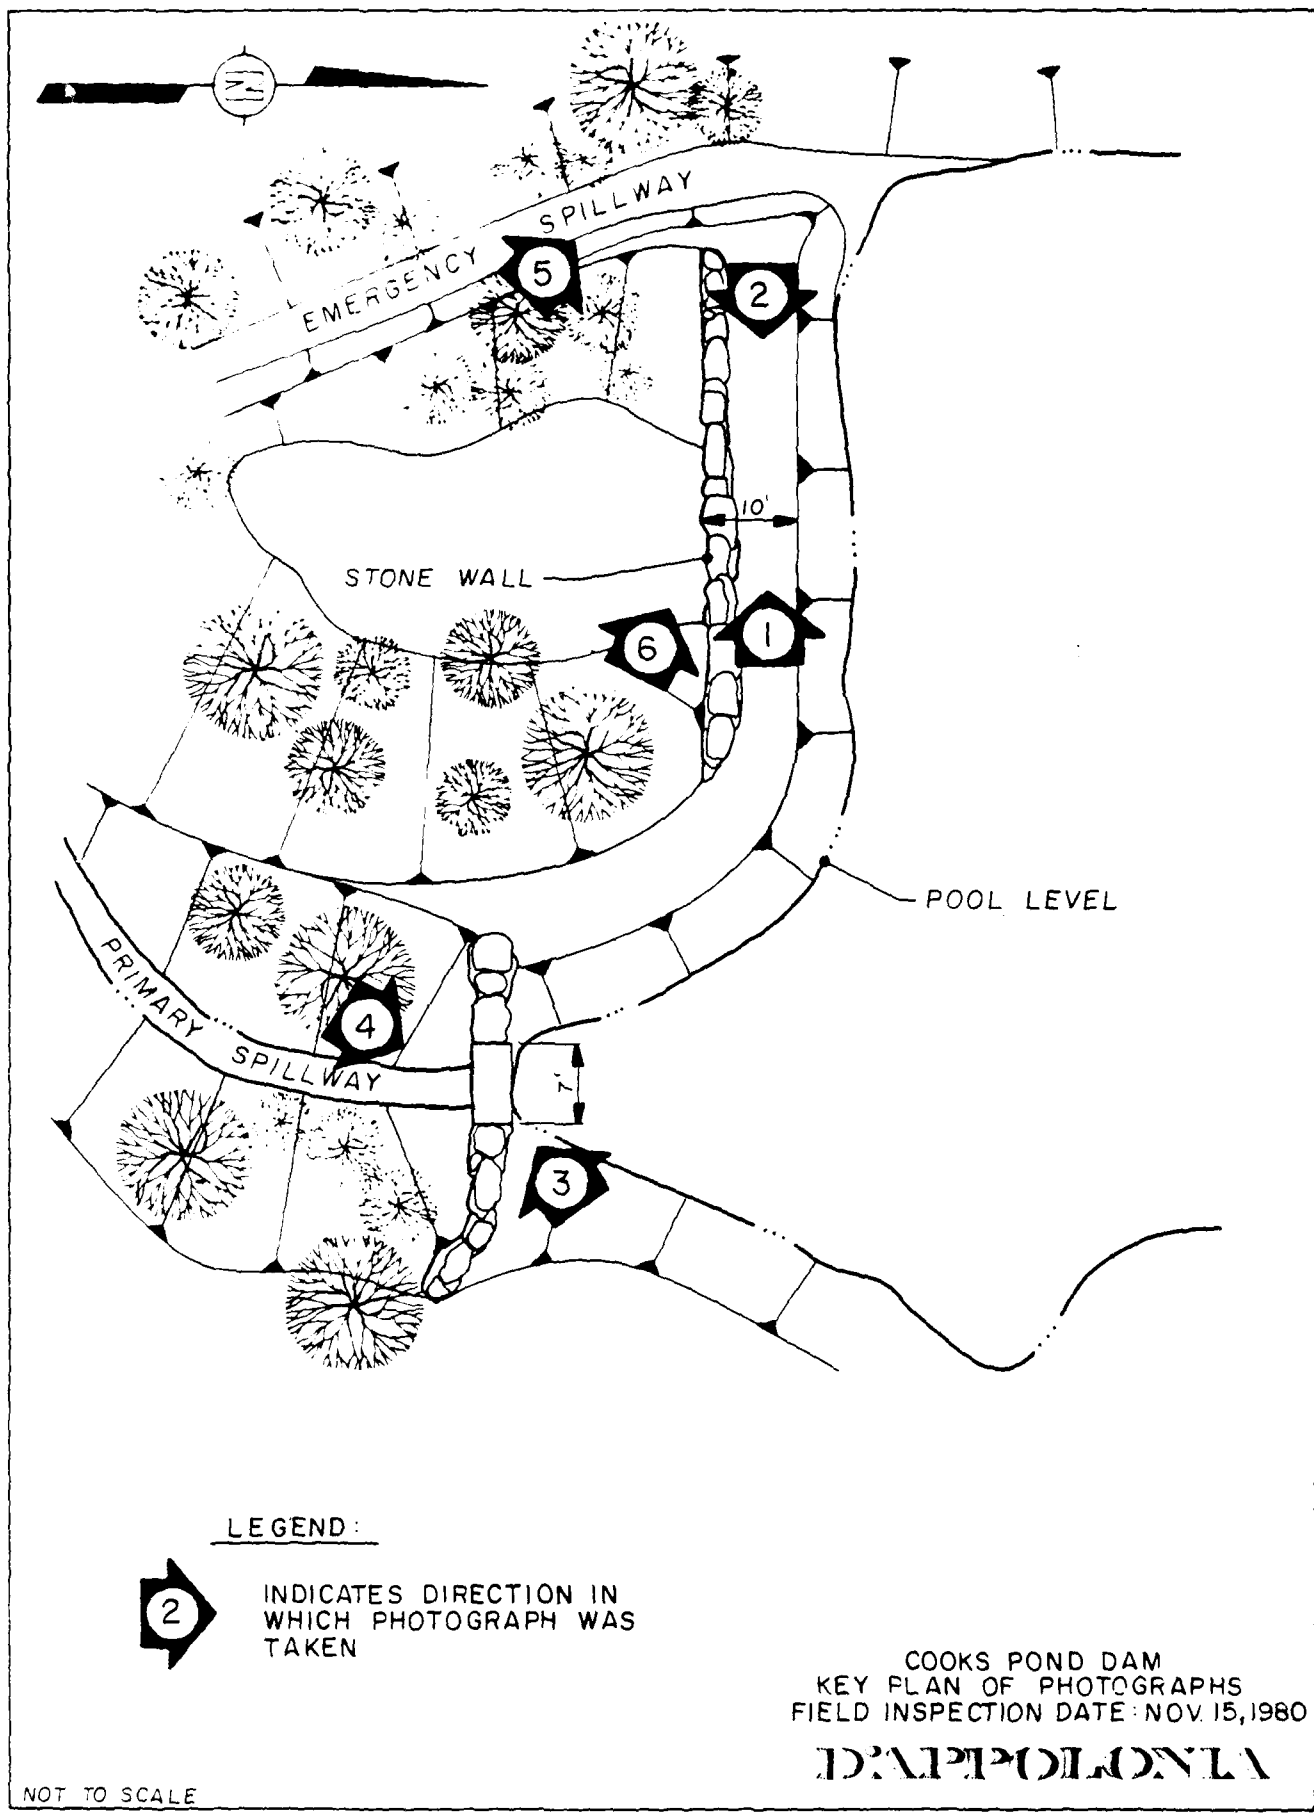
PHOTOGRAPH NO 1

1	Crest (looking west).
2	Crest (looking east).
3	Primary spillway (looking west).
4	Primary spillway (looking upstream).
5	Emergency spillway (looking upstream).
6	Downstream face of dam.
7	House - Potterville (mile 1.0).
8	Trailer - Potterville (mile 0.8).

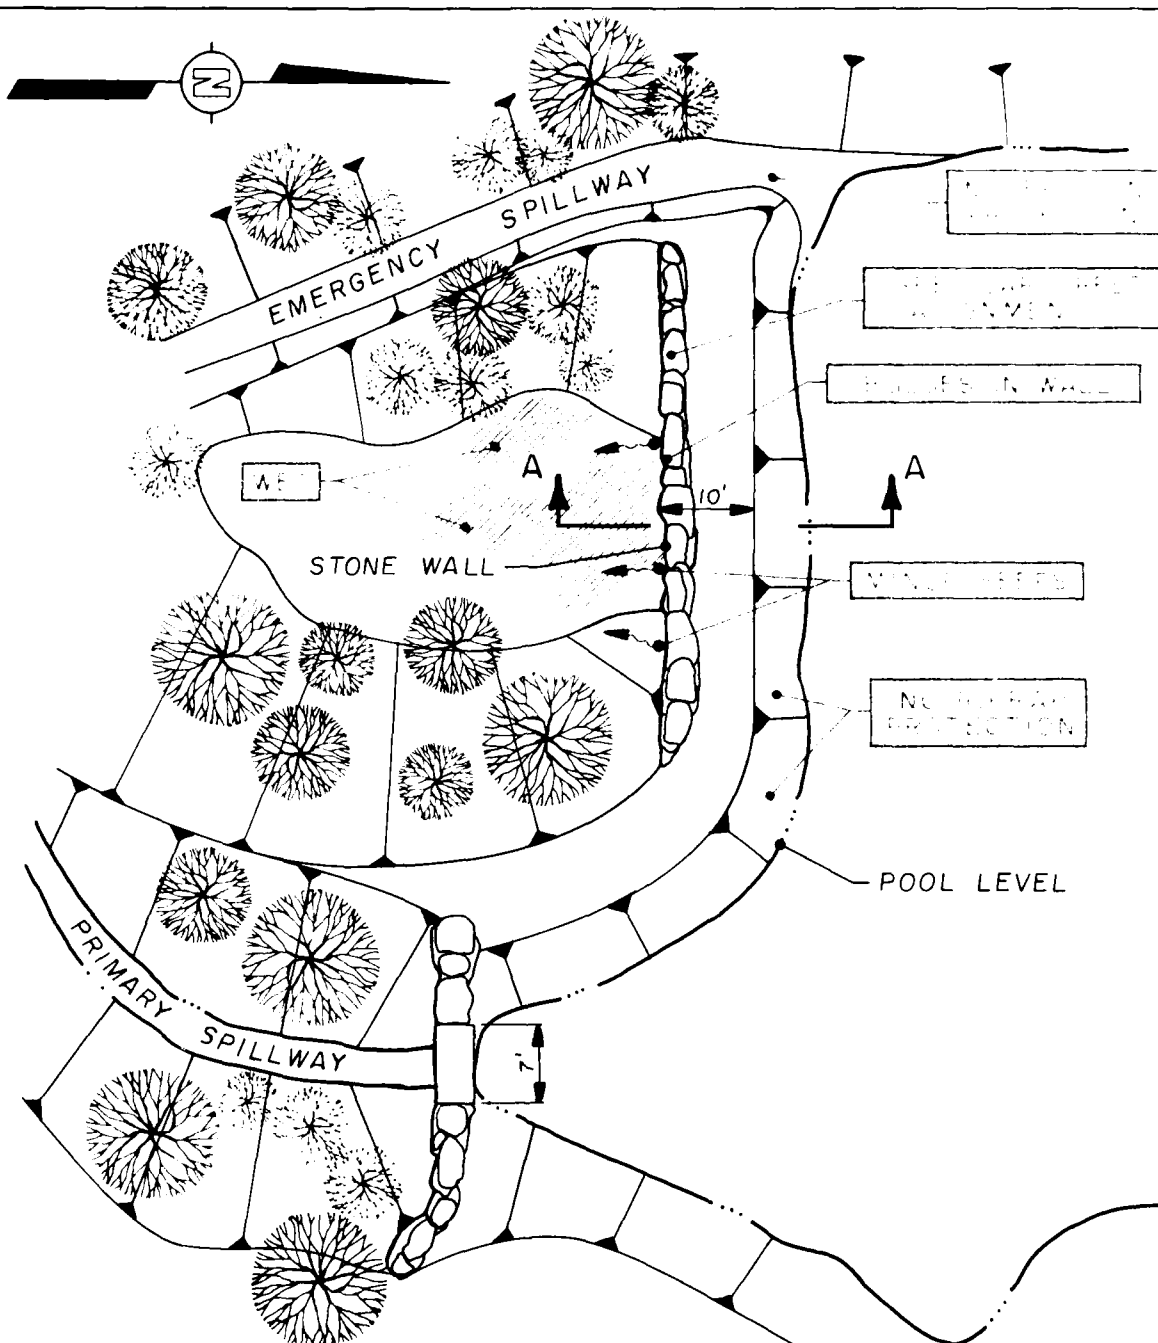
PLATE 2
COOKS POND DAM
GENERAL PLAN
FIELD INSPECTION NOTES
FIELD INSPECTION DATE NOV 15, 1980

The specific observations are illustrated in Plate 2 and in the photographs in Appendix C.

NOTE :
POOL LEVEL AT DATE OF INSPECTION:
6" BELOW SPILLWAY CREST
